# Nasty, Brutish and Short?; The Life Cycle of an Iron Age Roundhouse at Black Loch of Myrton, SW Scotland

Anne Crone, Graeme Cavers, Enid Allison, Kimberley Davies, Derek Hamilton, Andrew Henderson, Helen Mackay, Dawn McLaren, Jackaline Robertson, Lynne Roy & Nicki Whitehouse

<sup>a</sup>AOC Archaeology Group, Loanhead, UK; <sup>b</sup>Canterbury Archaeological Trust, Canterbury, UK; <sup>c</sup>School of Geography, Earth & Environmental Sciences, University of Plymouth, Plymouth Devon, UK; <sup>d</sup>SUERC, East Kilbride, UK; <sup>e</sup>School of Geography, Politics and Sociology, Newcastle University, Newcastle upon Tyne, UK

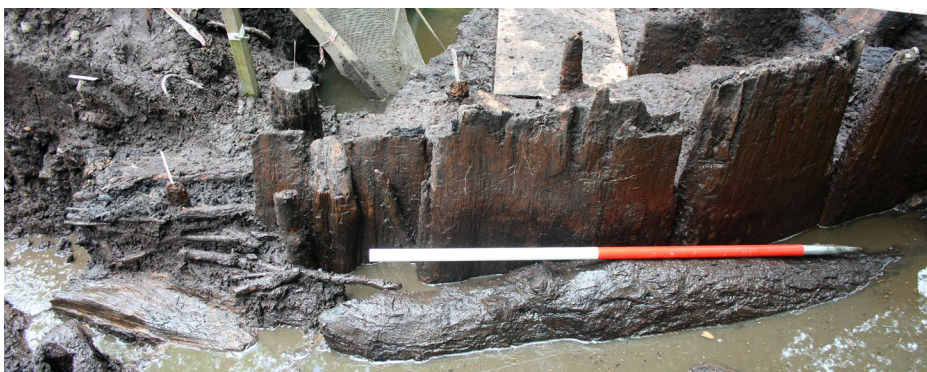
**Figure 3.** The oak plank façade to the left of the entrance. Courses of the wickerwork wall can be seen to the left, sitting just in front of the plank.

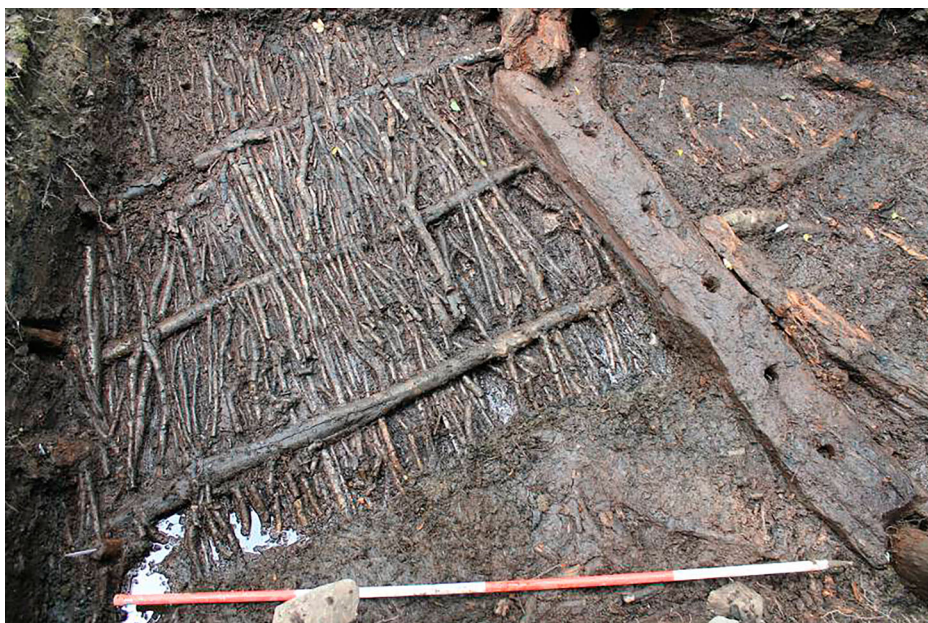
**Figure 5.** Sillbeam 223/1 *in situ* displaying stake holes and jointing around the posts. The stakes of the outer wall are visible to the left. The wickerwork screens formed the sub-floor of the Phase 1 building.

In between each post pair was a large alder sillbeam which had been laid directly over the wickerwork sub-floor. Most of these timbers were too decayed to preserve original carpentry details but the best-preserved example had been roughly squared, with five stake-holes cut along its length and shaped at either end to fit snugly around the upright posts, utilising a branch junction at one end to form this joint (Figure 5). These sillbeams would have created a major concentric division within the building (see below) but like the concave posts, they would have left no earthfast footprint.

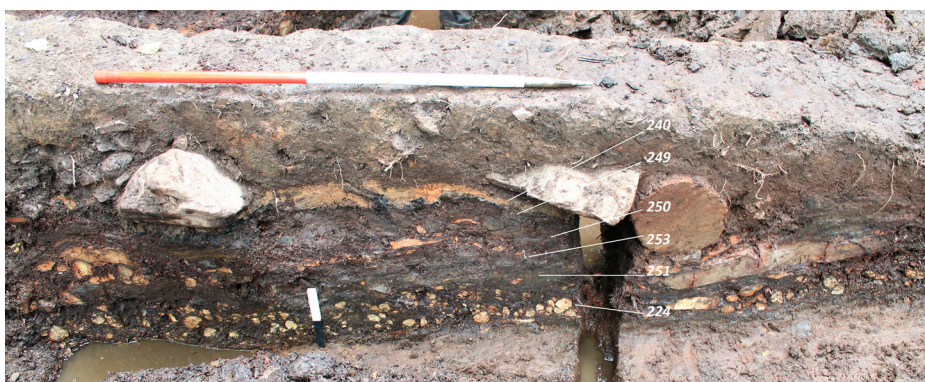
**Figure 7.** The full sequence of floor structures and surfaces is visible in this section. The Phase 1 wickerwork sub-floor lies at the base of the section, over the natural peat. Above this is [251], the plant litter floor surfaces, seen here as a grey-green layer. The Phase 2 brushwood sub-floor lies over this, followed by [250], the plant litter floors of this phase. The carbonised upper surface of this floor is visible, as is the orange clay laid immediately over it in Phase 3. The light brown peaty clay which covered the trench probably contains the mineralised remains of later organic floors belonging to this phase.

Immediately overlying [250] in large patches within the post-ring was a layer of carbonised plant litter between 0.03 and 0.04 m thick which is probably the burnt upper surface of [250] (Figure 7 – context 249). The survival of considerable quantities of charcoal, charred and reddened plant and fine mineral material suggests a relatively low temperature fire. It seems most likely that a spillage from the hearth caused the fire, which was prevented from spreading into the outer area beyond the post-ring by a screen of some sort. This conflagration probably brought this phase of activity in the house to an end.

In the final refurbishment of the house, the hearth was reduced to approximately half its original area from *circa* 7 m<sup>2</sup> in Phase 2–3.5 m<sup>2</sup> (Figure 7). A loosely constructed kerb of stones was laid just within and over the existing Phase 2 timber framework and a layer of clay, flecked with charcoal and burnt bone was spread over the surface area within the timber framework to form the foundation for Hearth 2. Within this outer kerb a line of four large oval boulders formed an inner kerb around the S edge which may have originally encircled the hearth and within this large greywacke slabs formed the working surface (Figures 7 and 10).

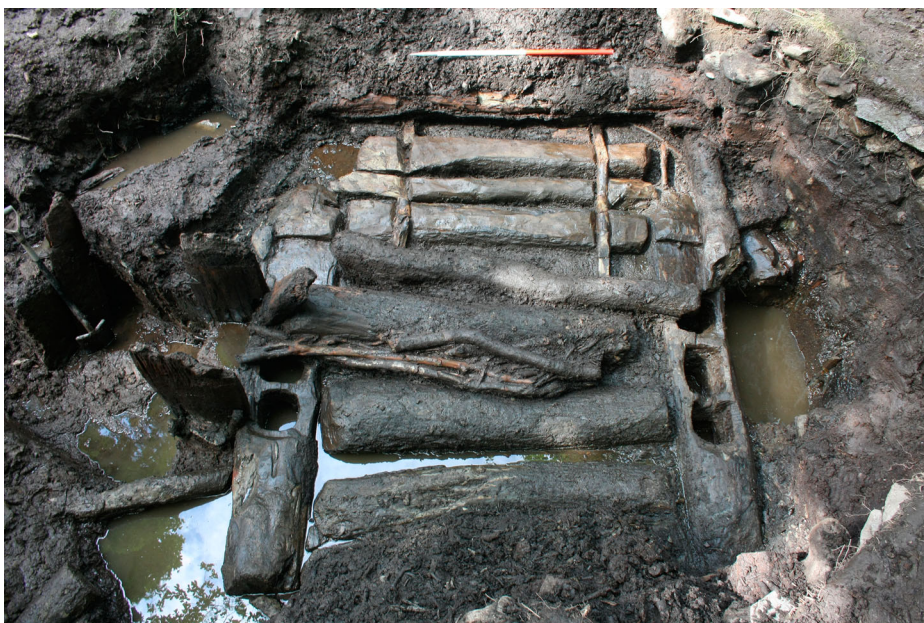
**Figure 8.** The Phase 1 entrance structure, looking into the building, with the oak planks of the outer wall still *in situ* where they abut the entrance.

The sides of the primary entrance structure were defined by two large radial logs 2.2 m long and set 1.70 m apart (Figures 2 and 8). A row of three closely-set mortices penetrated both logs, just at the point where the outer wallfaces met the entrance; these housed squared oak posts which would have formed the terminals of the outer wall and also lined the passage into the house. The inner ends of these radial sleeper beams had been dressed flat but the outer ends had not been worked, the bark still in place.

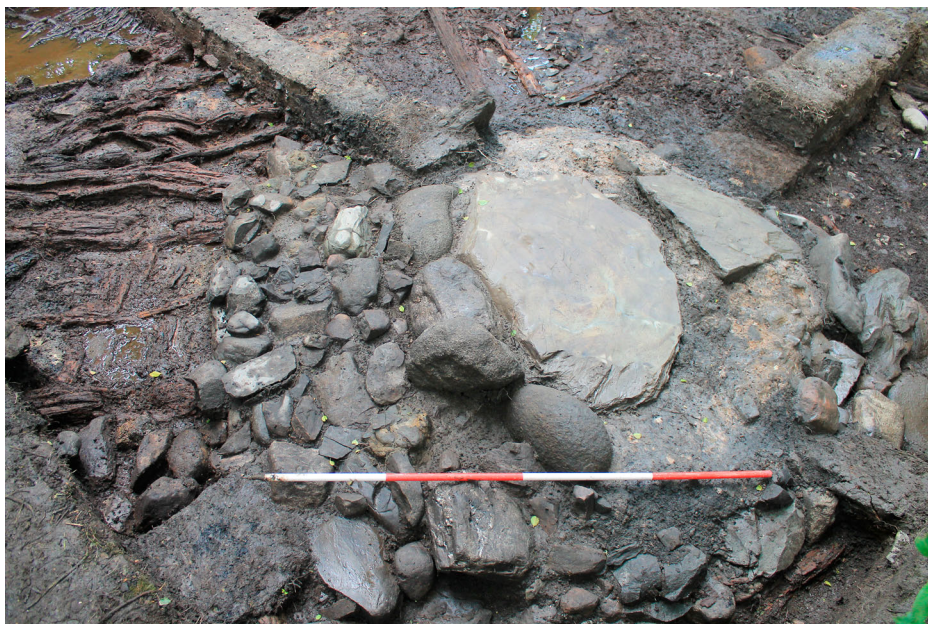
Figure 10. Hearth 2.

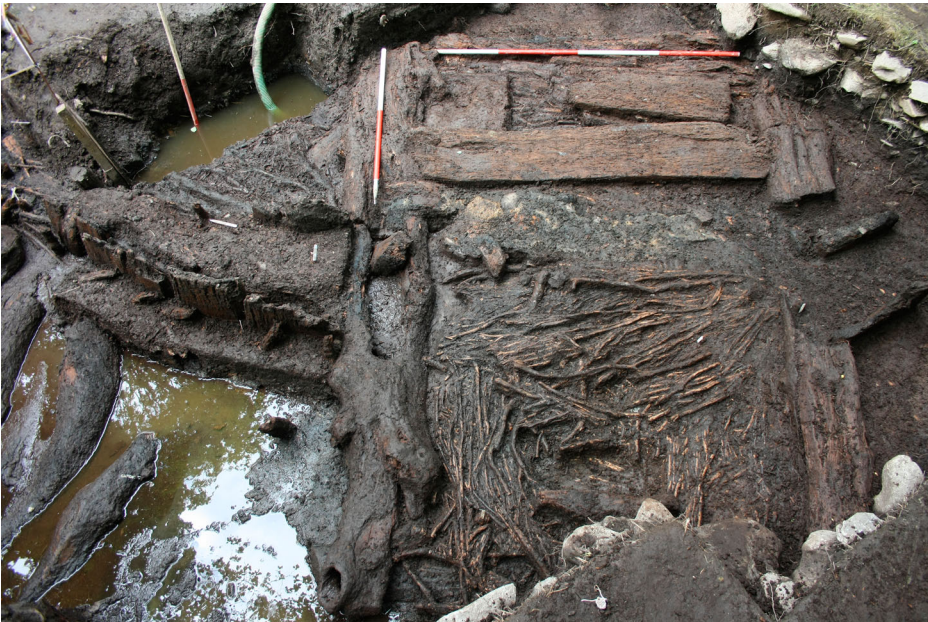
**Figure 11.** The Phase 2 entrance structure, looking into the building.

This framework was much more shoddily built than the Phase 1 entrance. New radial logs were laid directly over the Phase 1 logs (Figure 11). These radials were fashioned from undressed half-logs of alder, the curved surface of the log uppermost; it is possible that they are the two halves of the same log.

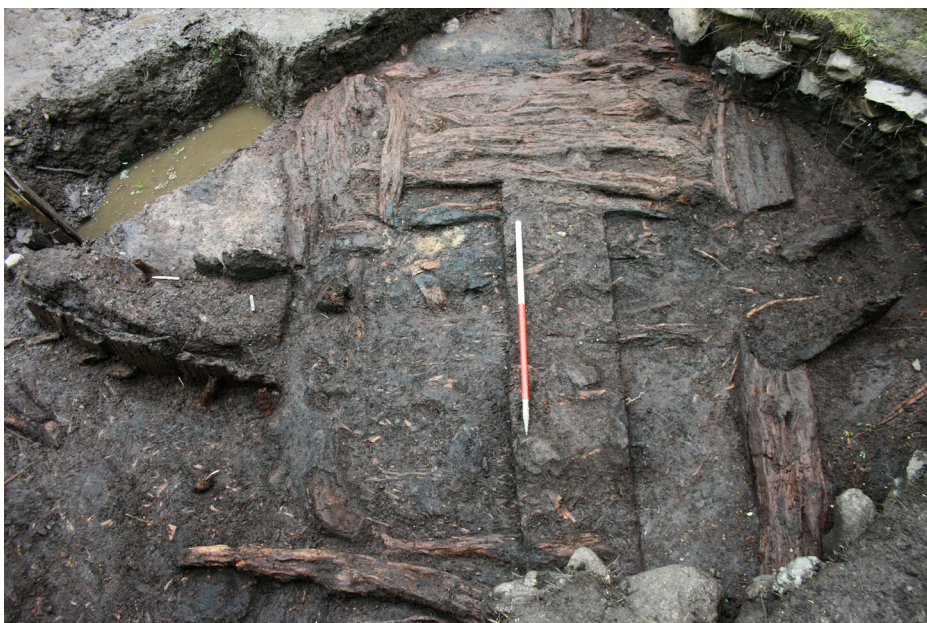
**Figure 12.** The Phase 3 entrance structure, looking into the building.

The final phase in the entrance area consisted of resurfacing rather than reconstruction and probably happened rapidly after Phase 2 because the new surfaces lay directly over the earlier ones with no evidence for any build-up of debris. The resurfacing consisted of a rectangular area of small alder logs, a 'welcome mat', which had been laid directly over the oak plank surface of the previous entrance (Figure 12). It was 2.2 m by 1.4 m, and was defined by two radial logs between which a continuous surface of tangential logs had been laid.

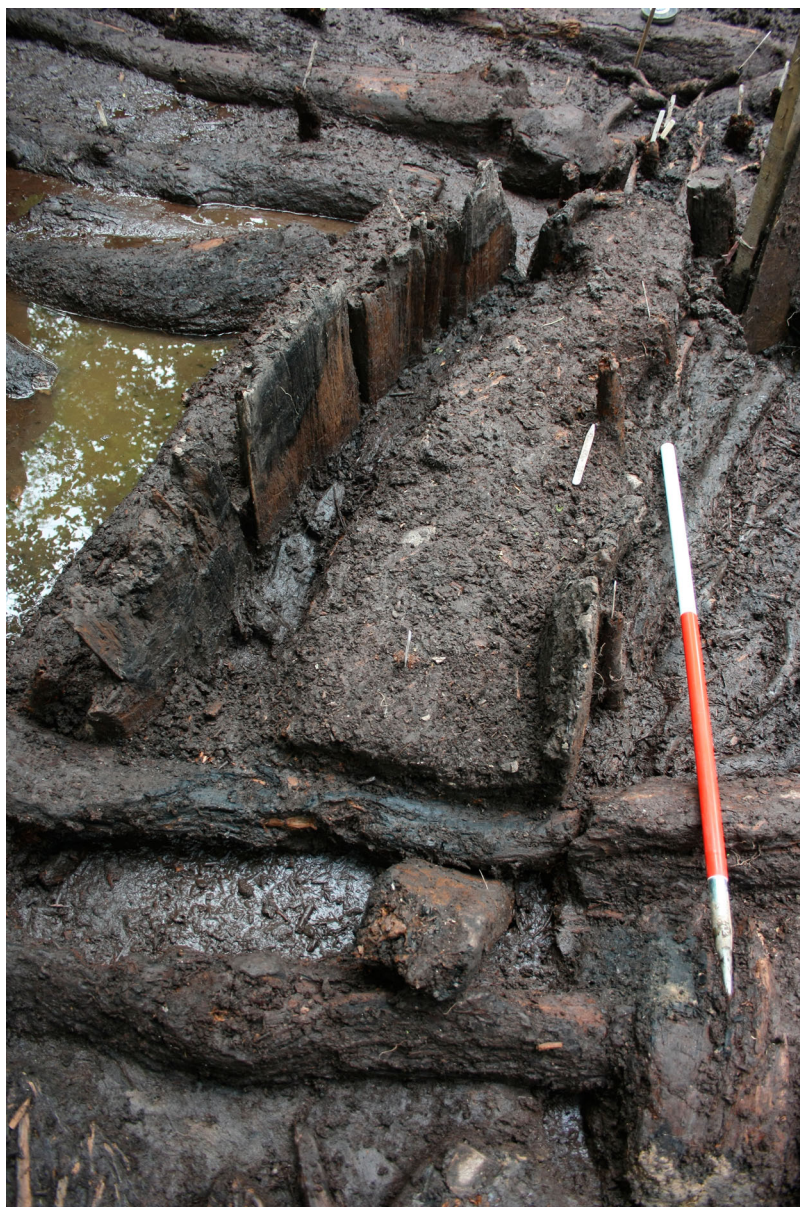
**Figure 15.** The plank walling of the outer wall at its junction with the entrance. Charring on the inner faces is visible. In the foreground the radial defining the lefthand side of the entrance is also clearly charred.

The bases of the posts and walls had obviously remained *in situ* so the structure was not entirely dismantled but there is evidence to suggest that a controlled burning event may have signalled the end of its life. The tops and inner faces of the planks on both sides of the entrance, as well as the tops of the posts in the eastern entrance terminal, were all charred, as was the radial log forming the eastern side of the Phase 2 entrance at its junction with the plank wallfaces (Figure 15). Within the cavity of the outer wall there were large quantities of carbonised withies, brushwood and plant remains. There is no evidence of burning within the interior or the entrance, apart from the charred tops of a few Phase 3 timbers and some of the trackway logs abutting the outer wall. This suggests that fires may have been set and contained within the outer wall. It also implies that, by the time the fire was started, the roof and the upper parts of the walls and posts had either been removed or had rotted down because there is no evidence, in the form of a charcoal horizon across the footprint of the house, to suggest that there had ever been a major conflagration. At one of the Iron Age farmsteads on the Assendelvers Polders in the Netherlands, some of the roof supports had been chopped off prior to abandonment, presumably to salvage usable timber (Therkorn et al. 1984, 365). The authors pointed out there that the roof would have had to have been dismantled before this could happen and this could also have occurred at Black Loch.
